NATIONAL PARK SERVICE  
Washington D.C. 20240B-4082  
MAGI # 0440822504HISTORIC PRESERVATION CERTIFICATION  
APPLICATION—PART 1

## PART 1 EVALUATION OF SIGNIFICANCE

1. Name of property: 641 Melvin DriveAddress of property: sameCity Baltimore County \_\_\_\_\_ State MD Zip Code \_\_\_\_\_Name of historic district in which property is located: Ridgely's Delight Baltimore County  
Historic District

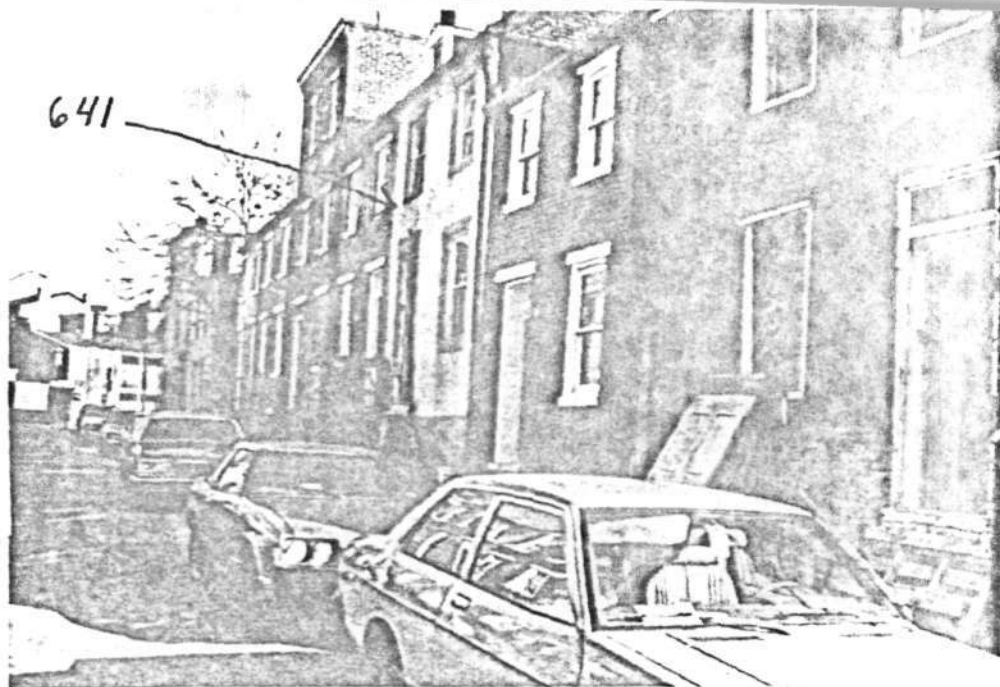
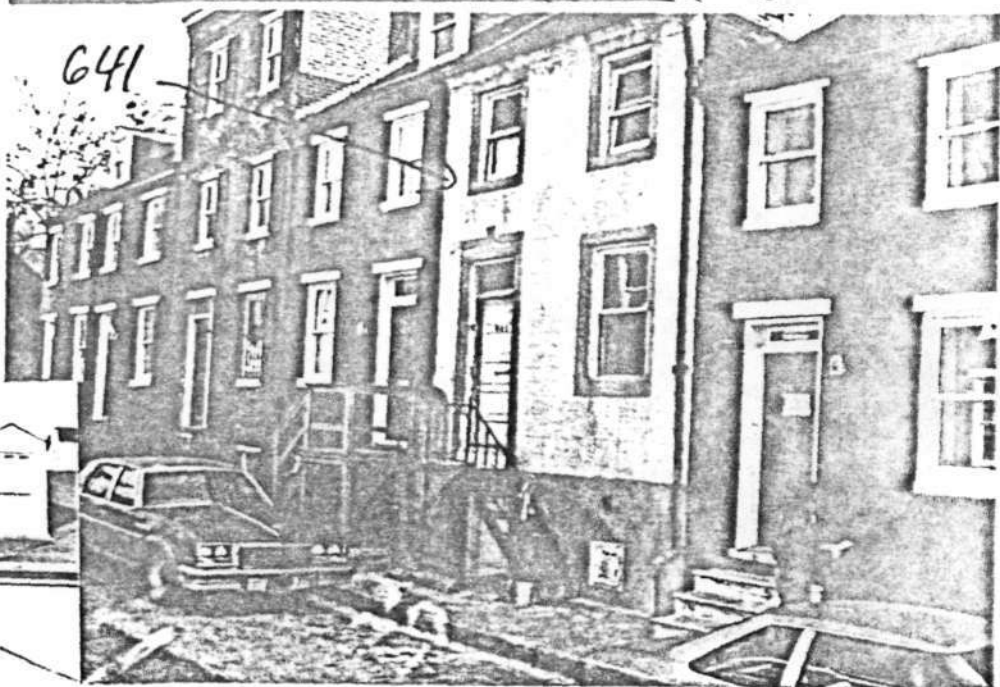
Two views of Front of house  
looking east from Penn Street.

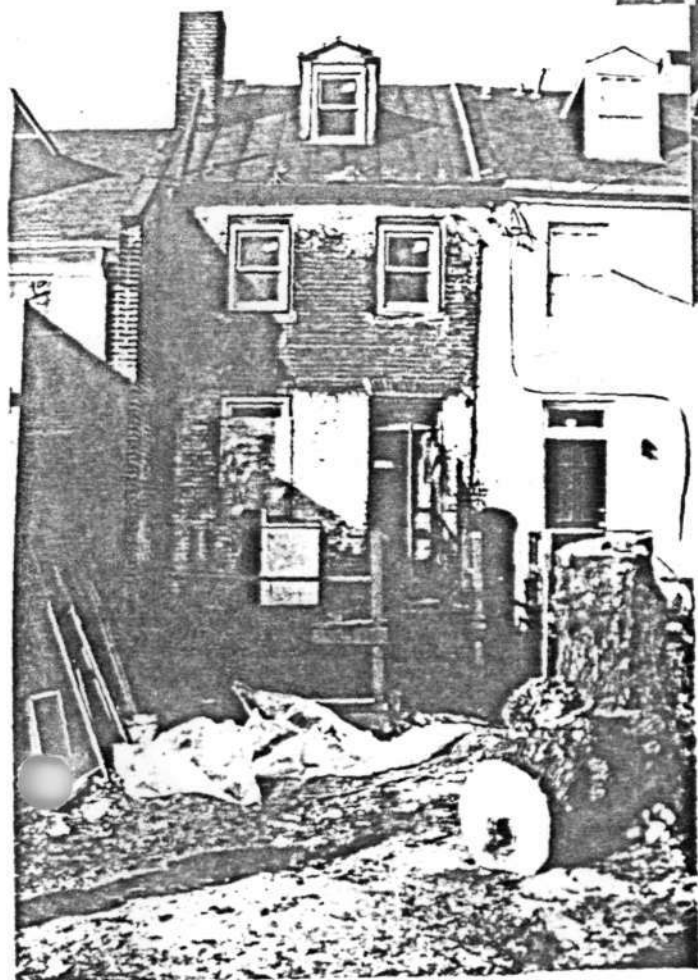
B-4082

View of rear of house showing  
original brick, treatment given  
renovated houses on block, de-  
generated porch, general mess  
in back yard.
